# Ferrymead Tram Tracts

The Newsletter of the Tramway Historical Society Incorporated

May 2022

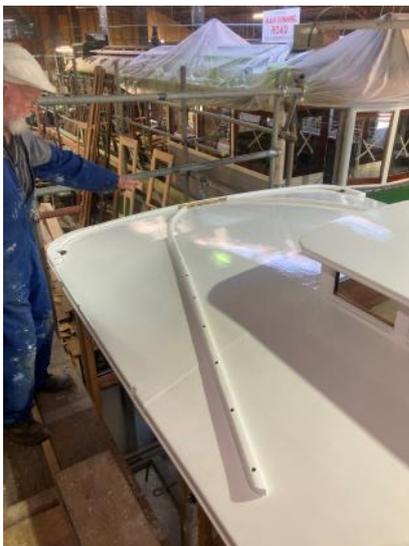
Don reports that they are working away on fitting the water guides on the roof to reduce the amount of water that will fall on the passengers that will be hanging on the side going up the hill! The water is channeled along these guides and down to a 6 holed manifold arrangement at the end of the roof, (this arrangement is shown on the lower photo.)

*Upper Left: Don showing me the roof guides.*

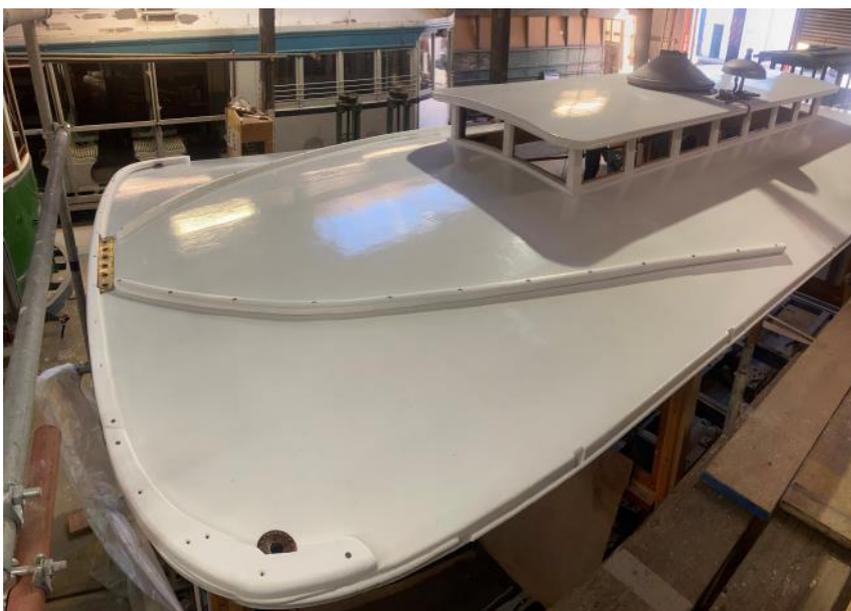
*Lower Right : a panoramic view of the new roof and to the right the Bell has been trial fitted and the roof vent is sitting in the spot where it will eventually be fitted.*

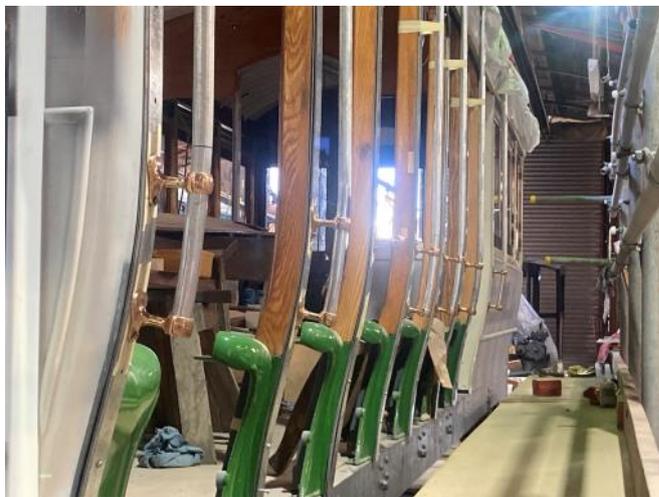
Heritage Craftsman Brian Fairbrass has been busy making the handrails for the sides of the open section, there are 16 in total and have many curves that need to be correct. There is plenty of patience required to do such a job as they have to be hand fitted to fit the various pillars, also some of the 16 have a double duty as downpipes for the guttering above them.

*Upper Right: The new handrails in place on the Left side.*

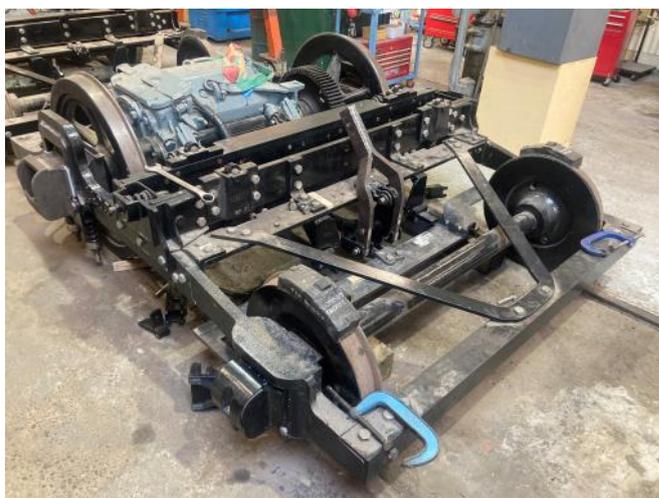
Heritage Engineer Bob Williams has been making good progress with the brake equipment on the trucks, this has included the manufacturing of new spreader beams and machining all the new beam hanger castings, this equipment is all now stripped down again ready for the components to be sand-blasted and painted in Resene Acrythane 2 part paint.

*Upper Mid: The nearly completed truck showing the new brake gear all in place.*

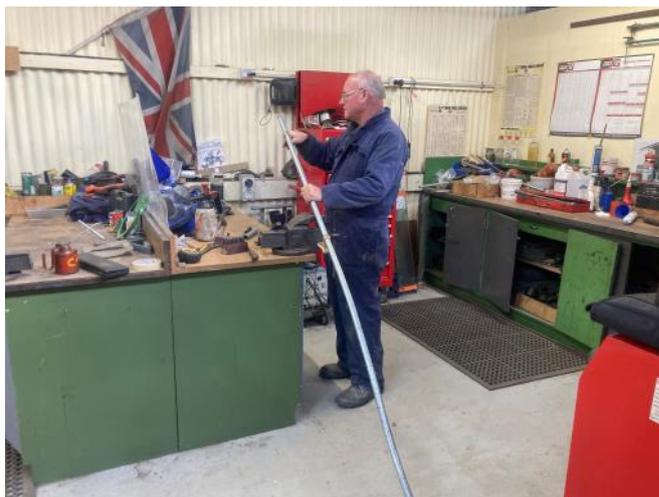
*Middle: Brian Fairbrass fettling a handrail pipe to get the various castings to fit.*

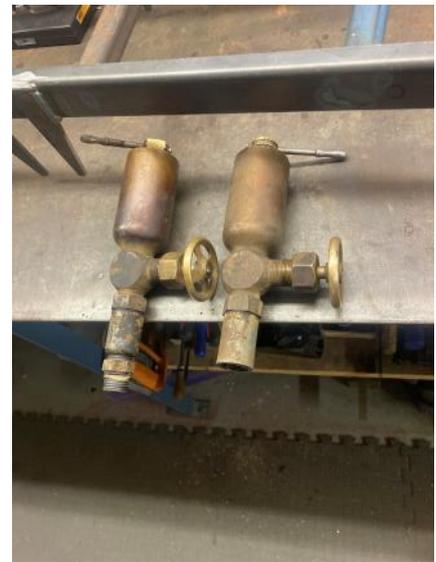
During the week I took the Lubricators home to strip them down and service them, both in reasonable condition, one had a broken feeding tube inside, luckily I managed to unscrew the stub end of the tube out using the tail of a file, and the thread turned out to be a 3/16" 32TPI thread, widely used in model engineering so I had the right gear on the job to repair it.

Top: The lubricators have been serviced and are ready to go back on.

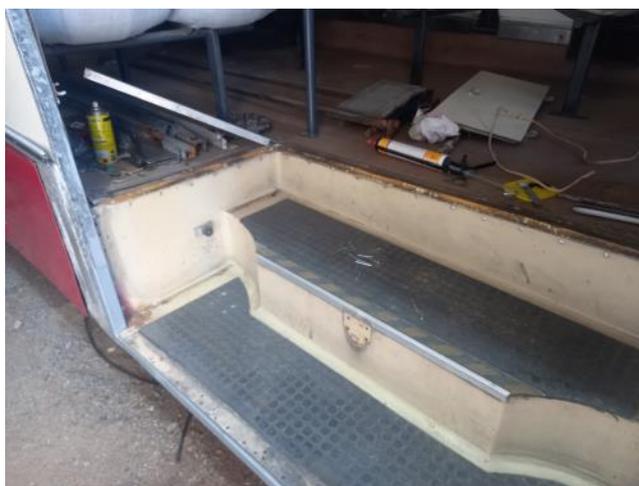
Both sets of steps have had the zinc paint put onto the new steelwork and the fibreglass step units have been refitted and riveted into place. The posts the doors rotate on have had a tidy up and a coat of protective zinc.

*Upper Mid: The fibreglass step refitted in 612*

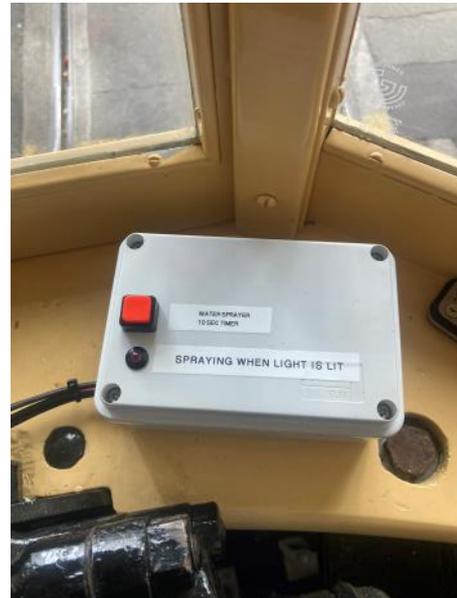
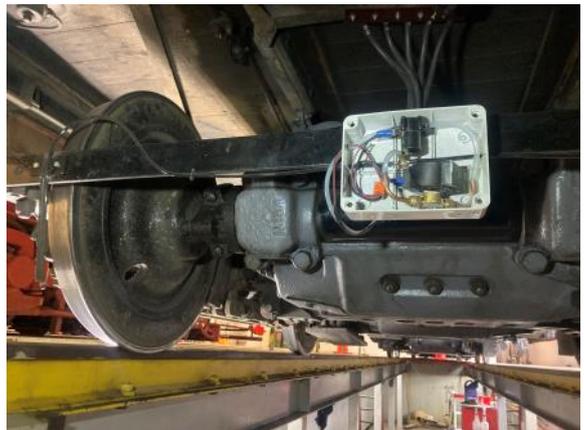
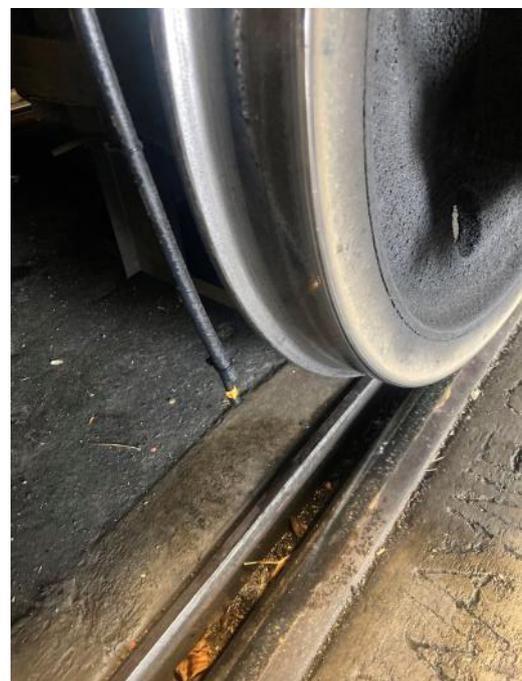
Anyhow we have come up with a system of which does the job nicely, there are two sprayer jets, one each in front of the two leading wheels, the water is then pumped by a 24V windscreen washer motor and a 24v controlled water solenoid in a box underneath the tram.

Inside each tram is 2 water tanks, located one in each end. With the various different vehicles we have, locations of the tanks differ, but most are under the seats.

The operation of the sprayer system is down to the drivers discretion, in the cab of each tram is a box with a button on the top of it, this activates a 7 second timer of which makes the task simple as the drivers hand is not occupied holding down the button constantly while the sprayers are being operated.
